Inspection Report

Sample Report

5637 Sample Road

Unit 602

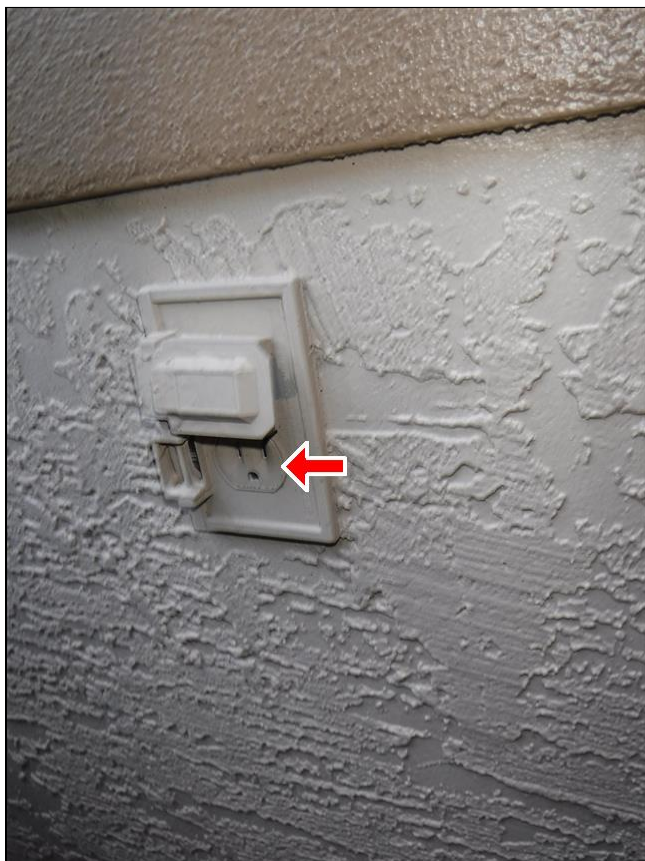
6.18 Exterior outlet weather proof cover damaged under spare bedroom window (front).

6.18 Item 1(Picture) damaged weather cover

1. Exterior outlet weather proof cover damaged under spare bedroom window (front).

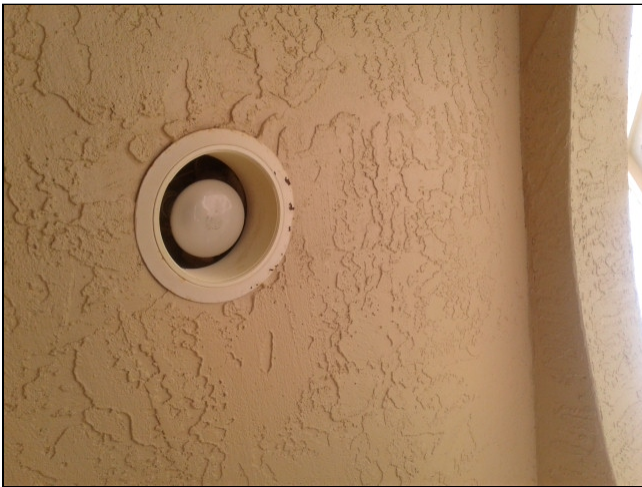
7.3.A Entry light at front door not functioning at time of inspection. Recommend replacing light bulb.

7.3.A Item 1(Picture) Front entry light not functioning (check bulb)

4. Entry light at front door not functioning at time of inspection. Recommend replacing light bulb.

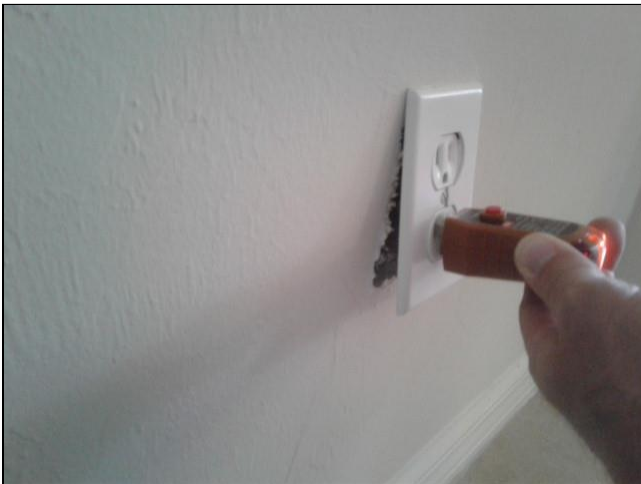
7.4.B Outlet in wall near piano found to be broken and loose in wall. This can resulting in electrical shorting an is hazardous. Recommend consulting licensed electrician for replacement of broken outlet and securing of all other loosely installed outlets found.

7.4.B Item 1(Picture) Broken outlet in living room

5. Outlet in wall near piano found to be broken and loose in wall. This can resulting in electrical shorting an is hazardous. Recommend consulting licensed electrician for replacement of broken outlet and securing of all other loosely installed outlets found.

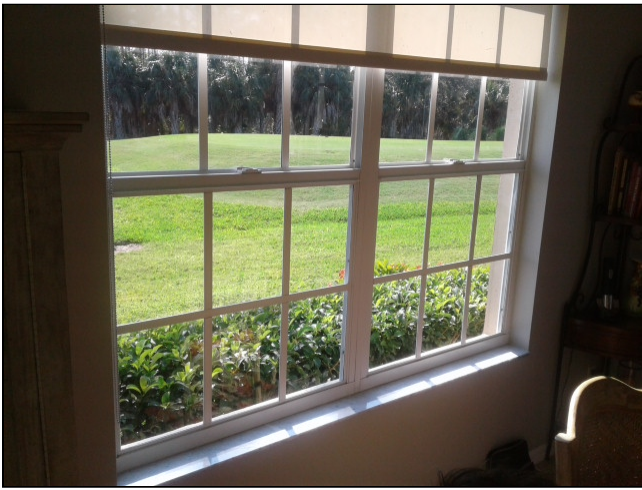
7.6.B The windows in the breakfast nook area where missing screens.

7.6.B Item 1(Picture) Rear windows without screens present (breakfast nook)

6. The windows in the breakfast nook area where missing screens.

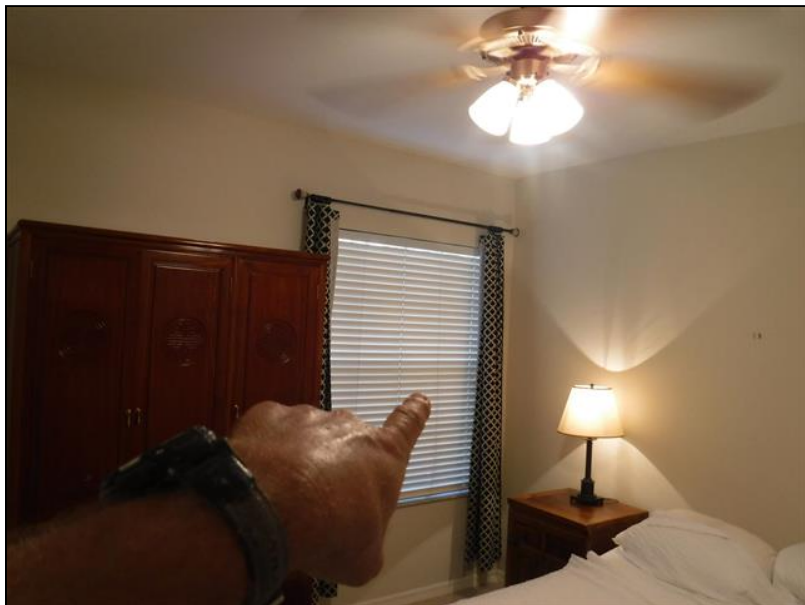
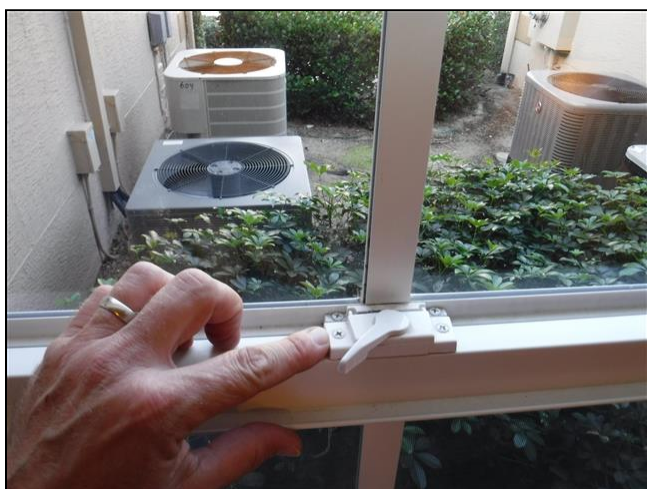
7.6.E Spare bedroom front window lock not engaging properly resulting in non-secured window. Recommend replacement or repair of lock.

7.6.E Item 1(Picture) Front BDRM window not secured

7.6.E Item 2(Picture) Locking not securing in window

7. Spare bedroom front window lock not engaging properly resulting in non-secured window. Recommend replacement or repair of lock.

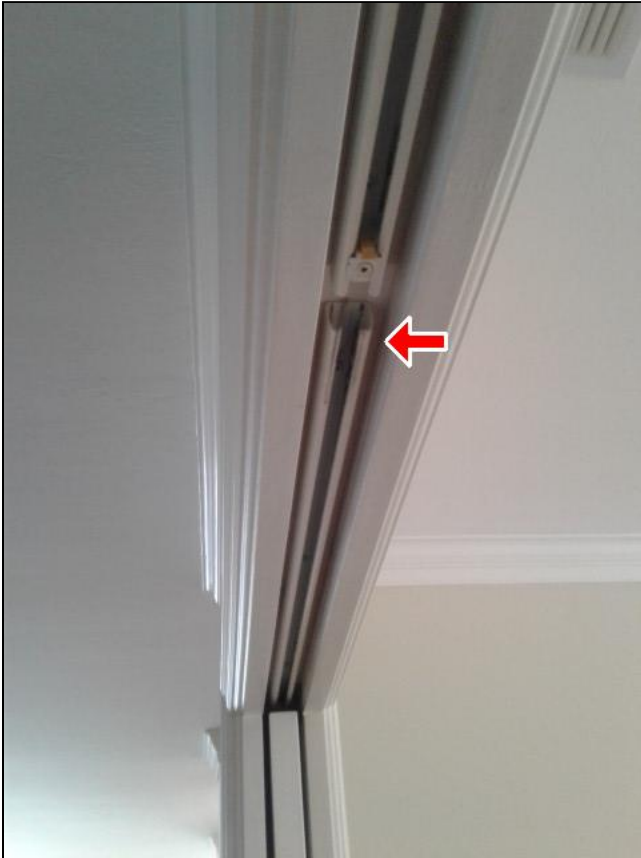
7.5.F Pocket door missing stop in top track on left side. Door difficult to close if pulled out to far. Recommend having door height adjusted and stop installed.

7.5.F Item 1(Picture) left side pocket door missing stop in overhead track

8. Pocket door missing stop in top track on left side. Door difficult to close if pulled out to far. Recommend having door height adjusted and stop installed.

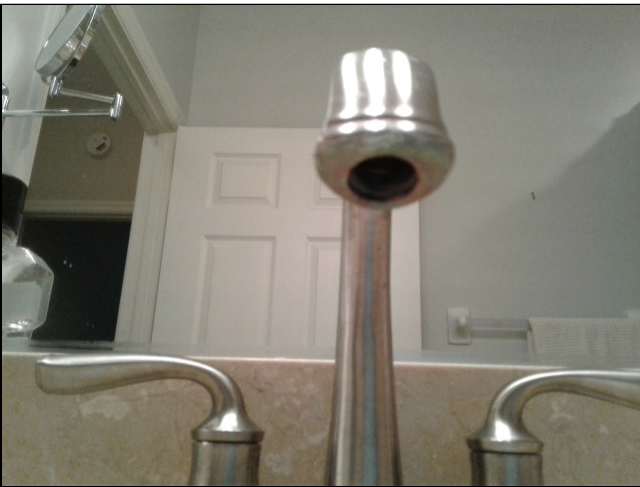
9.18.A Faucet in hall bath missing flow regulating aerator screen.

9.18.A Item 1(Picture) Sink faucet missing flow regulator screen

9. Faucet in hall bath missing flow regulating aerator screen.

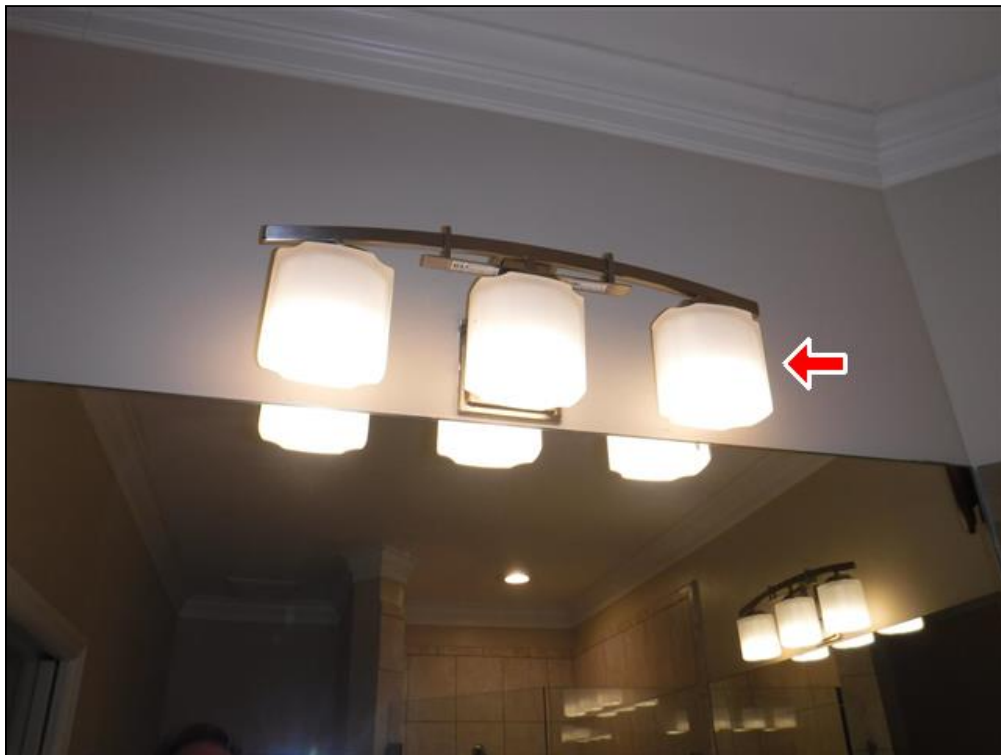
9.7.B Dimmer switch installed with non-dimming bulbs in vanity lights. Recommend changing all bulbs to dimmable type.

9.7.B Item 1(Picture) Flickering bulbs (not dimmable)

10. Dimmer switch installed with non-dimming bulbs in vanity lights. Recommend changing all bulbs to dimmable type.

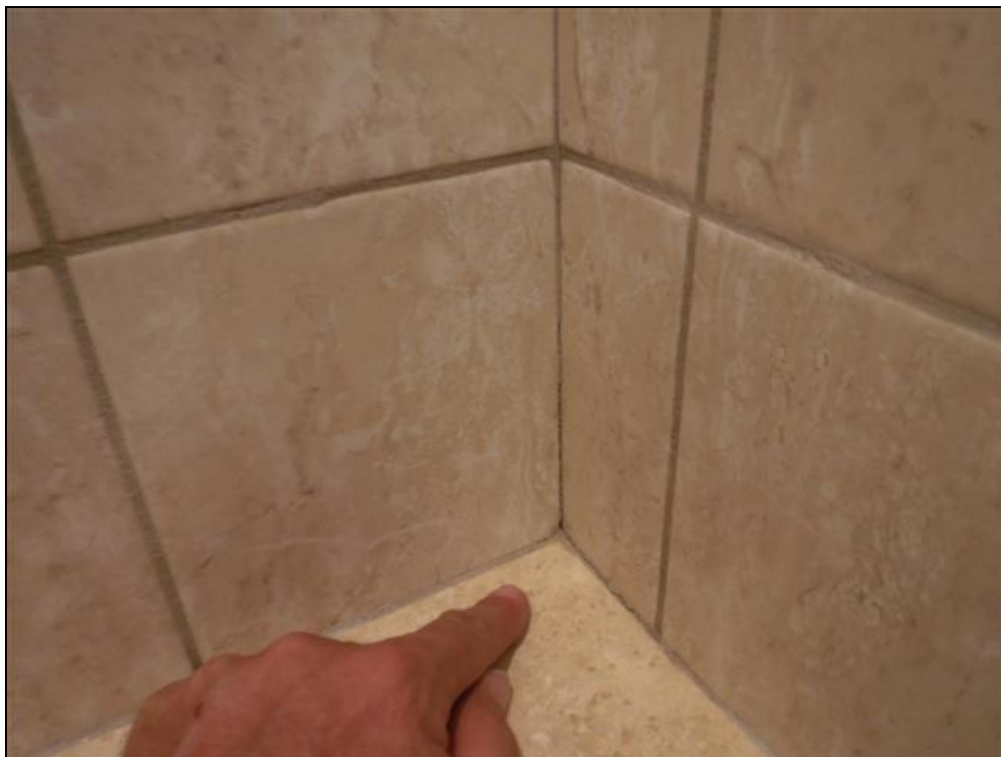
9.14.B Minor grout cracks present in corner at shelf. Recommend sealing all cracks to prevent tile damages and microbial growths.

9.14.B Item 1(Picture) Minor grout cracks in corner

11. Minor grout cracks present in corner at shelf. Recommend sealing all cracks to prevent tile damages and microbial growths.

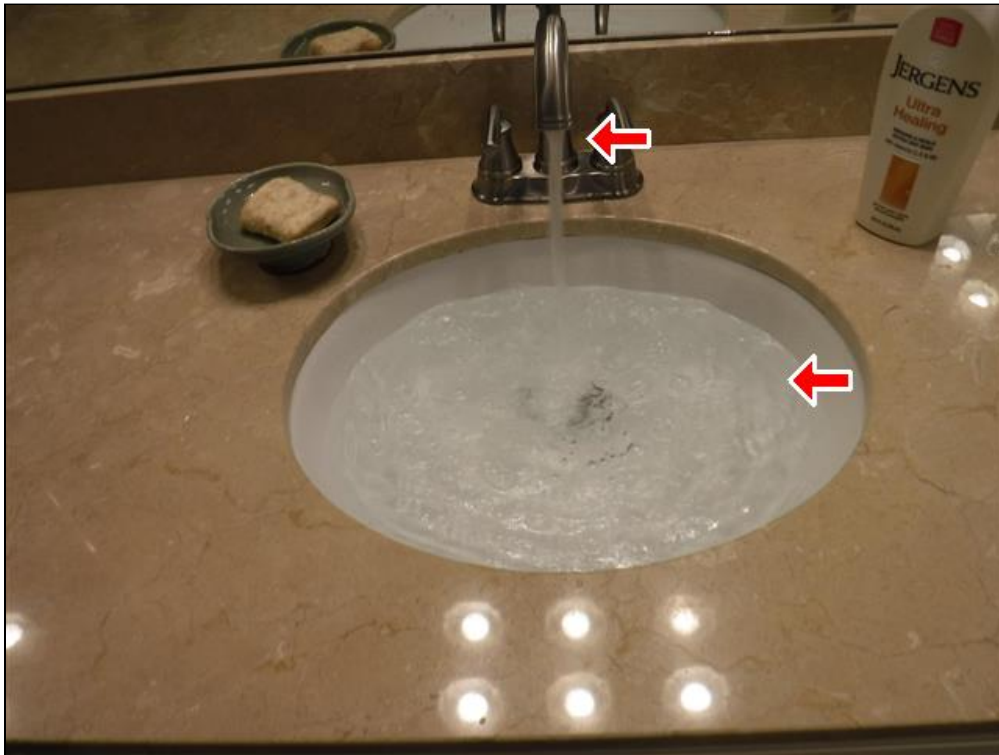
9.18.B Aerator not installed in sink on left side.

Sink slow to drain on left side.

9.18.B Item 1(Picture) Missing aerator and slow draining

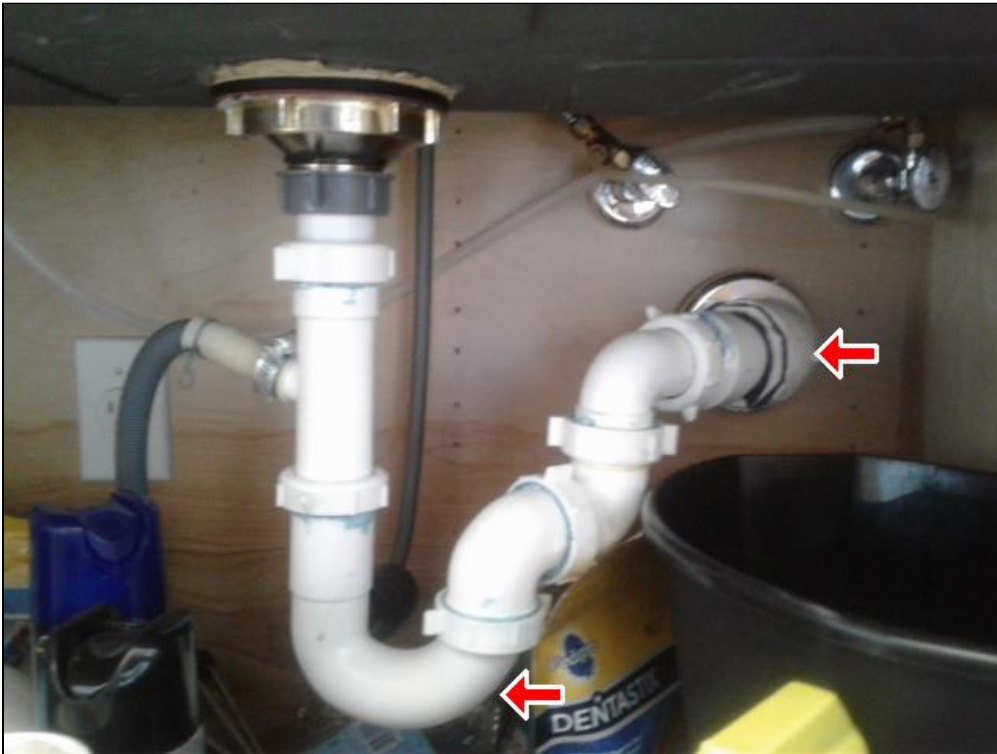
10.21 Drain assembly of kitchen sink not correctly installed with drain trap set well below discharge line. Recommend consulting a licensed plumber for correction and improved sink drainage.

10.21 Item 1(Picture) Sink trap weir set too far below drain line

14. Drain assembly of kitchen sink not correctly installed with drain trap set well below discharge line. Recommend consulting a licensed plumber for correction and improved sink drainage.

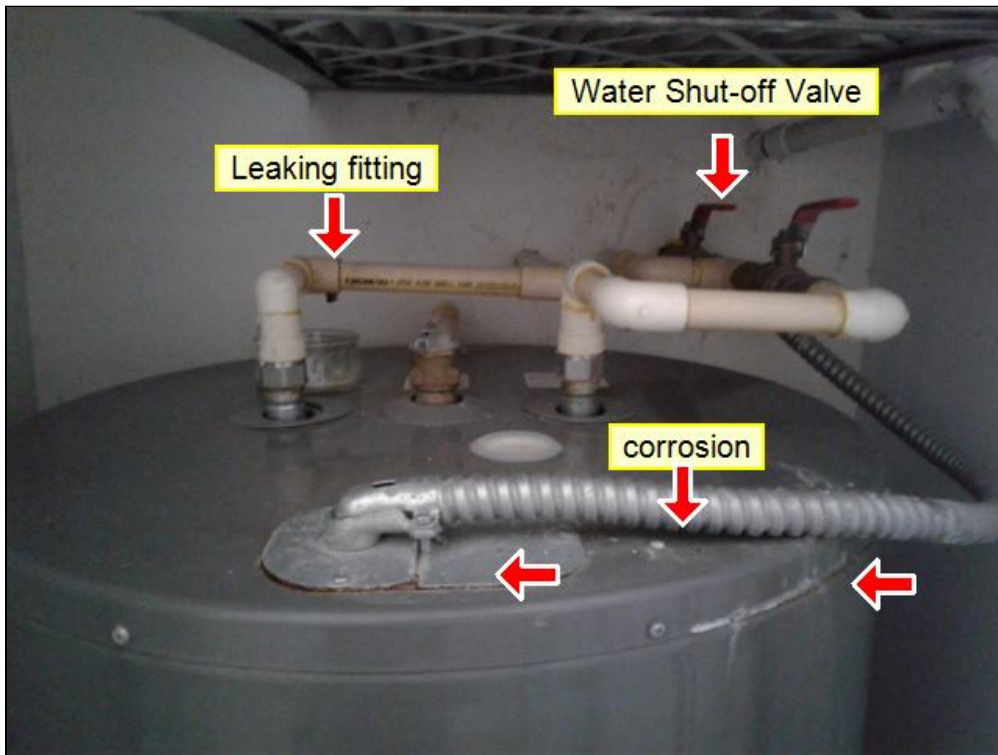
12.7 Hot water tank, located in laundry room closet, was noticed to have minor corrosion present on exterior from water leakage/dripping from A/C condensate line above tank. Additionally the hot water line on tank was also noticed to be leaking at fitting.

Main water shut-off valves for unit 602 located at hot water tank. First valve coming out of wall is the main shut-off, second valve shuts off water supply to hot water tank only.

Hot water tank dated 2014, with average life expectancies of 8-12 years.

12.7 Item 1(Picture) Hot water tank (laundry closet)

16. Hot water tank, located in laundry room closet, was noticed to have minor corrosion present on exterior from water leakage/dripping from A/C condensate line above tank. Additionally the hot water line on tank was also noticed to be leaking at fitting.

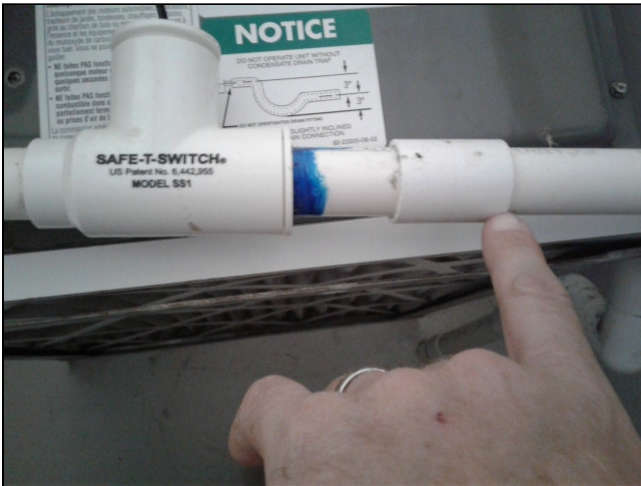
14.0 A/C condensate line leaking at coupler fitting resulting in hot water tank corrosion. Consult HVAC or plumbing contractor for repairs.

14.0 Item 1(Picture) Condensate line leaking at fitting(s)

17. A/C condensate line leaking at coupler fitting resulting in hot water tank corrosion. Consult HVAC or plumbing contractor for repairs.

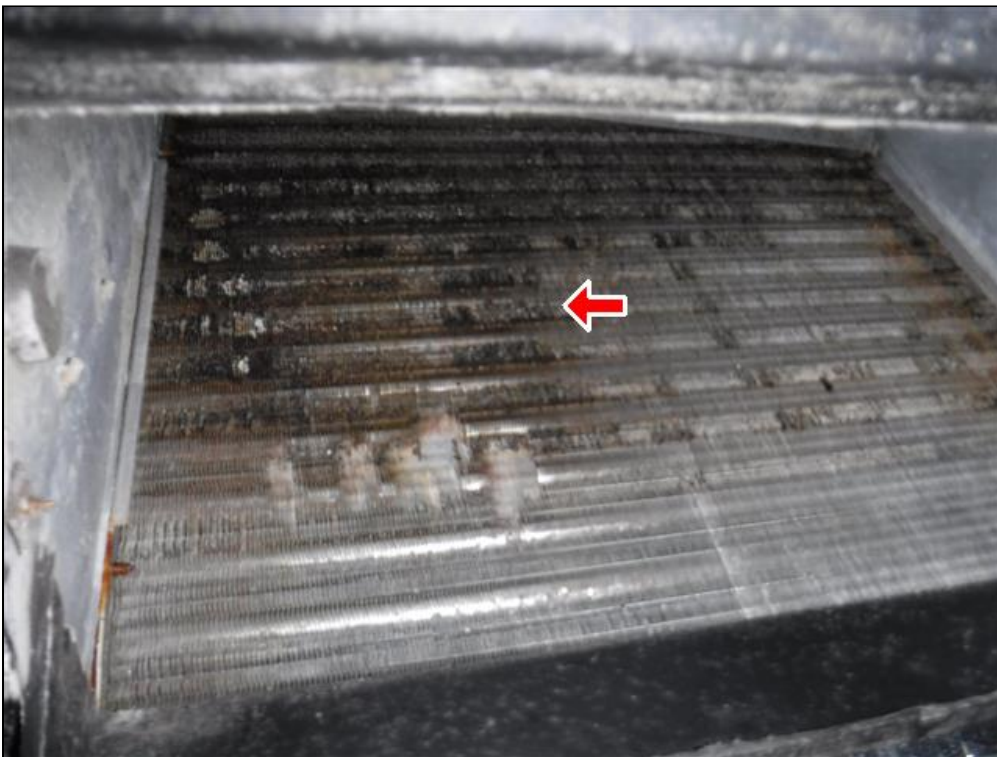
Interior A/C coil notice to have some microbial growths and other grime present. Recommend consulting HVAC professional for proper coil cleaning and full system check.

14.0 Item 2(Picture) Microbial growths on coil

Interior A/C coil notice to have some microbial growths and other grime present. Recommend consulting HVAC professional for proper coil cleaning and full system check.
